Intel[®] Pentium[®] II Xeon[™] Processor Specification Update

Release Date: September 2000

Order Number: 243776-024

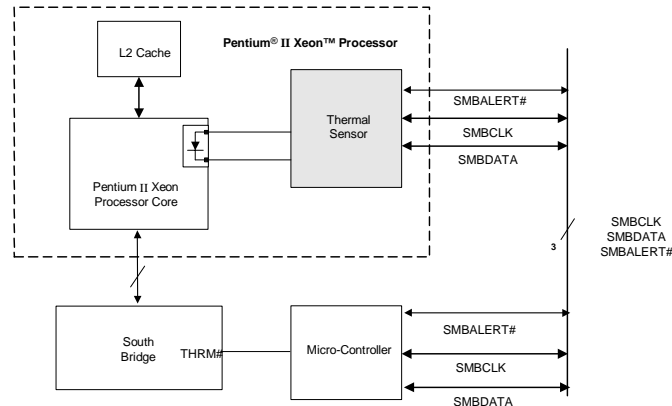
Figure 1. An Example of Microcontroller Driven Thermal Management

D30. Thermal Sensor May Assert SMBALERT# Incorrectly

Problem: The Pentium II Xeon processor has a thermal sensor that monitors the processor core's temperature. The thermal sensor asserts SMBALERT# if the processor temperature exceeds the temperature limits set in the Alarm Threshold Registers (T_{HIGH} , T_{LOW}). It also sets the corresponding Status Register bits to identify the cause of the interrupt. Figure 1 gives one example of the how the SMBALERT# signal could be used in a system.

Under the conditions described below, the thermal sensor incorrectly generates the SMBALERT# interrupt. All of the following conditions must be met to trigger a false interrupt:
